**MOBILE CRANE / BOXLOADER RESTRICTIONS
FIPASS NORTH CENTRE BARGE**

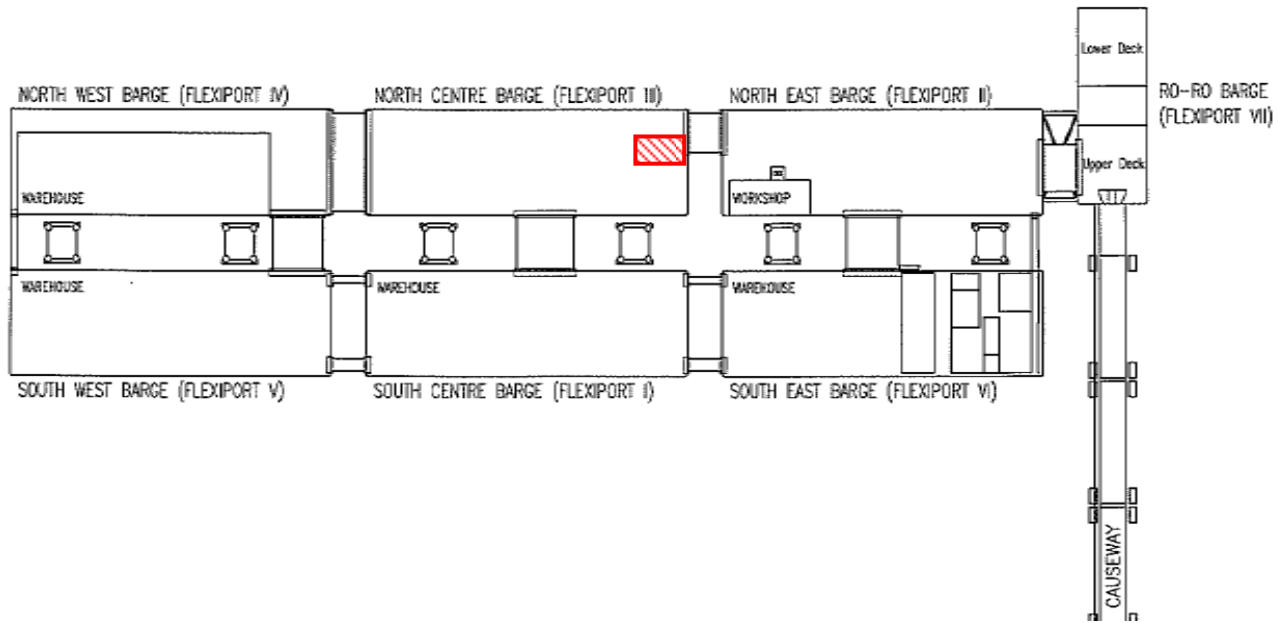
Figure 1: 5 Starboard Inner, North Centre Barge, FIPASS
(Ref: FIPASS SURVEY 2020, ANALYSIS AND RECOMMENDATIONS, MD2052D-2B, page 7).

During a recent engineering deck survey, it has been identified that some of the below deck bulkheads and stiffeners were suffering significant thinning. However, they still maintained sufficient global capacity.

The report concluded that the advanced corrosion from the 2015 report was confirmed in this ballast tank, but there was no physical deformation despite the heavy deterioration. This is the main roadway area and the deck plate and structure were not showing signs of fatigue or damage. Containers were not loaded here but care should be taken not to use the crane above this tank should the requirement arise.

Therefore this Safety Notice is to inform all FIPASS Users that no mobile cranes or boxloader operations are to take place over the area outlined in red on Figure 1 above (5 Starboard Inner). This area will also be clearly identified on the deck, but if in any doubt please speak to the Duty Operations Manager and they will advise accordingly.
